# Building Inspection Report

7940 48th Ave S Seattle, WA

**Inspection Date:**  
8-8-16

**Report Number:**  
McKenna - Dunn 2016

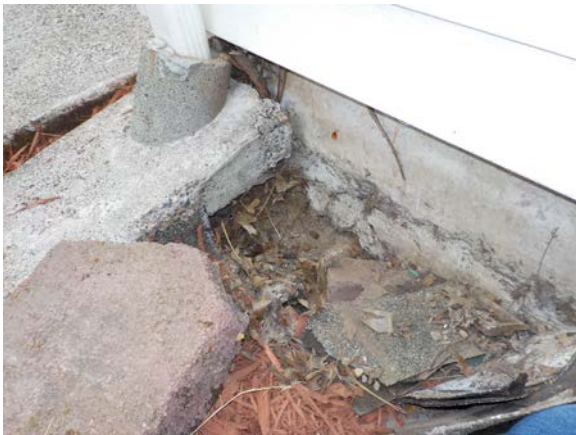
SE corner

- **Monitor:** Minor settlement cracks were observed in the foundation walls. This implies that some structural movement of the building has occurred. Cracks of this type should be watched for any sign of additional movement. In the absence of any sign of ongoing movement, repair should not be necessary.
- **Improve:** The SE foundation should be further evaluated by a foundation specialist/company for further evaluation and repair as needed.

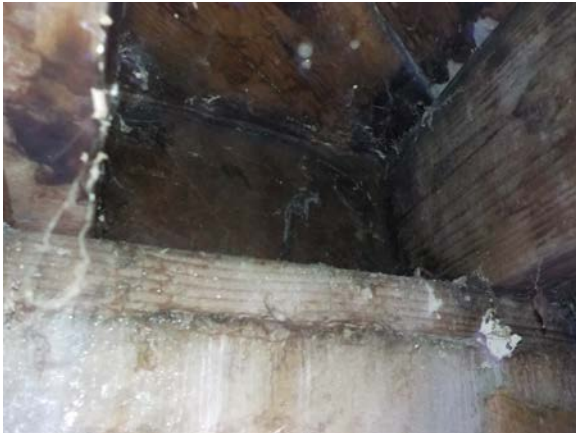
rot under shower

- **Major Concern, Repair:** The floor structure shows evidence of rot under the bathtub shower area (on a beam and on the subfloor). Rot weakens the structure and causes building damage. Rot develops where untreated wood is in contact with moisture and/or where wood/soil contact exists. Damaged wood should be repaired or replaced and the conditions that have promoted the rot should be corrected.

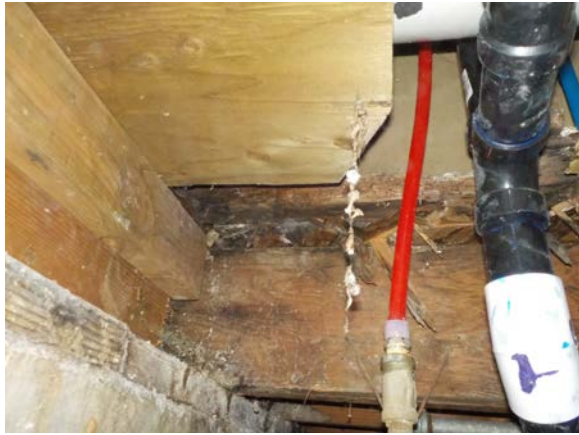
rot on joist under tub

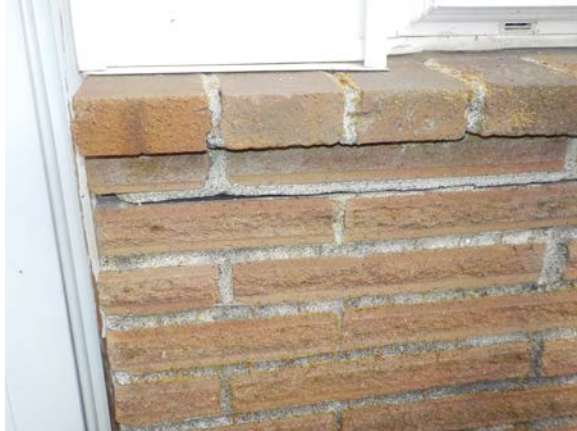
front brick settling

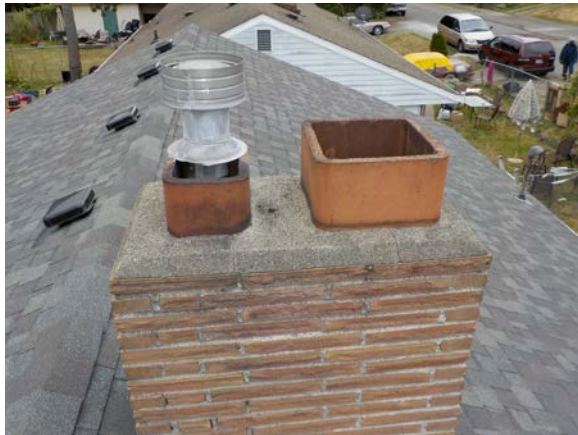
Chimney caps needed

- **Repair:** A rain cap and vermin screen should be installed on the masonry chimney and the chimney flue should be checked for damage. Damaged flues can be unsafe.

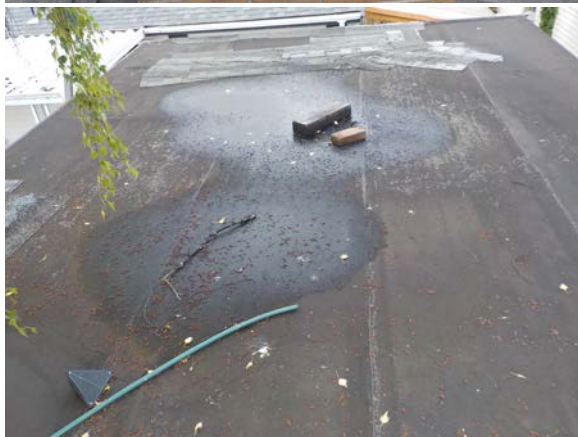
- **Major Concern, Repair:** The garage roofing is at end of life and should be replaced. Water appears to pond on the membrane. This leads to a shortened life and increased potential for damage if leaks occur. When re-roofing, the roof should be appropriately sloped or drains should be added. Expect to replace this roof soon.
- **Improve:** The roof drains needs improvement and should be cleared and maintained free of debris to reduce roof damage and risk of leaks.
- **Repair:** A coating to provide ultraviolet protection should be provided for the membrane.

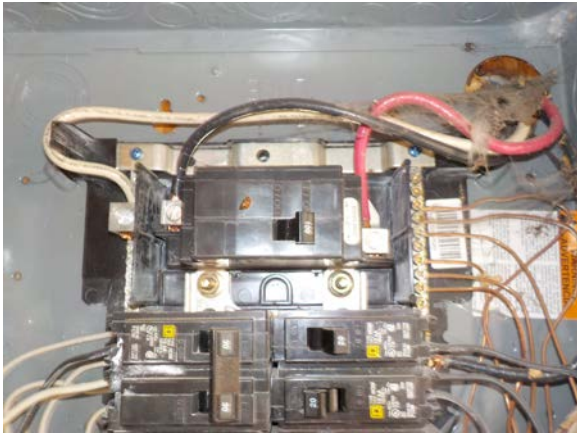
smaller than 100 Amp gauge on sub panel

- **Repair:** Oversized breakers within the garage auxiliary panel should be further evaluated by a licensed electrician and corrected as needed prior to close.
- **Improve:** One of the breakers was turned off labeled OL? The directory is incomplete. The electrical panel should be further evaluated by a licensed electrician as well.

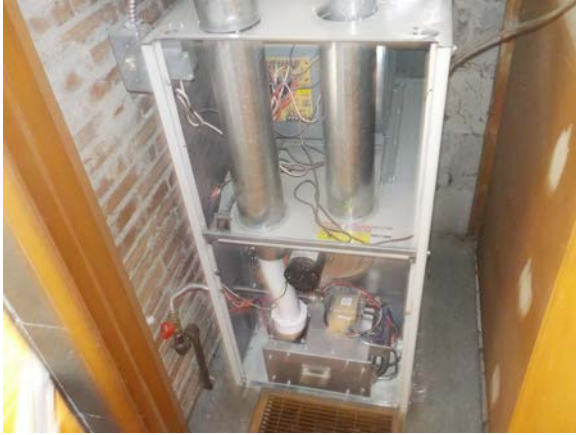
furnace

- **Major Concern, Repair:** Given the age of the furnace, replacement should be expected soon.
- **Repair:** The dirty air filter should be replaced.

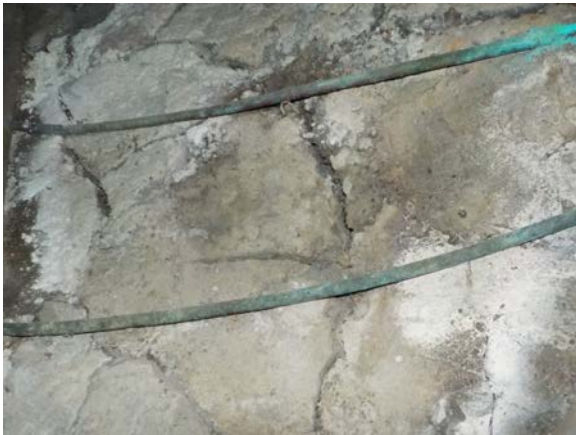
oil fuel lines in crawl space

- **Major Concern, Repair:** It is suspected that an underground oil storage tank **MAY** exist on the property. If the tank has leaked *you could face a costly environmental cleanup* task since the US EPA has indicated that leaky residential oil tanks are an environmental hazard for which Federal spill cleanup regulations could apply. Buried tanks which have not leaked can be opened, cleaned, and filled in-place or they can be removed entirely.

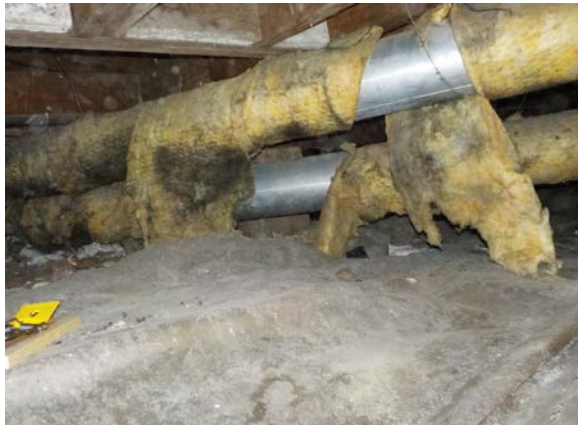
crawl space ductwork

- **Repair:** There is evidence of vermin activity in the crawl space. A pest control specialist should be consulted for treatment and control advice.
- **Repair:** Damaged ductwork in the crawl space should be repaired. Improper duct work increases heating/cooling costs and can also cause building damage.

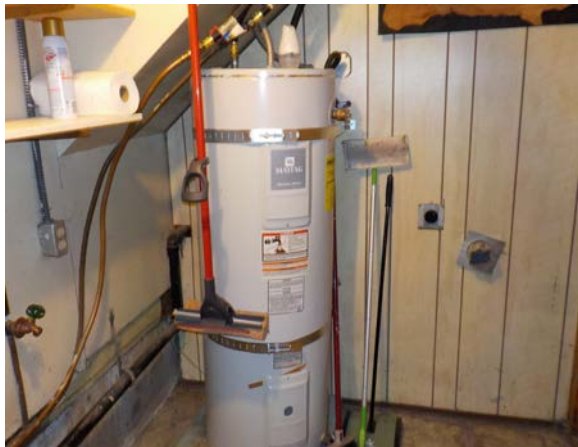
hot water heater

- **Improve:** The water heater is an (14 years) old unit that may be approaching the end of its useful life. It would be wise to replace for a new unit. One cannot predict with certainty when replacement will become necessary.

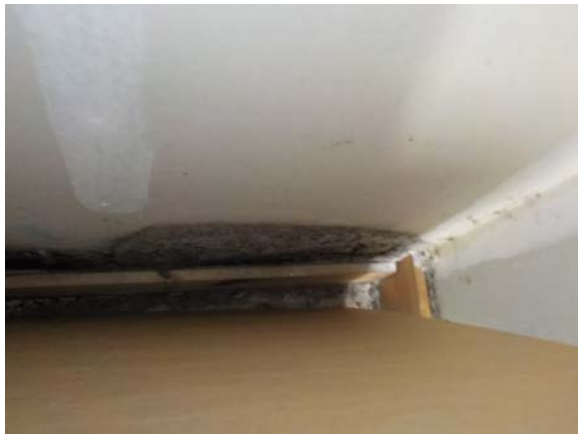
fungal growth in garage

- **Major Concern: Repair:** Water damage was noted in the laundry room and also in the garage. This fungal growth that was found in both of these locations show signs of what appears to may be mold and should be further consulted by an expert on the topic. Mold is not part of an inspection.
- **Monitor:** Textured or “popcorn” ceiling material was visible. Asbestos detection or testing is beyond the scope of this inspection.
- **Monitor:** An apparent water staining was noted in the West closet of the above bedroom.

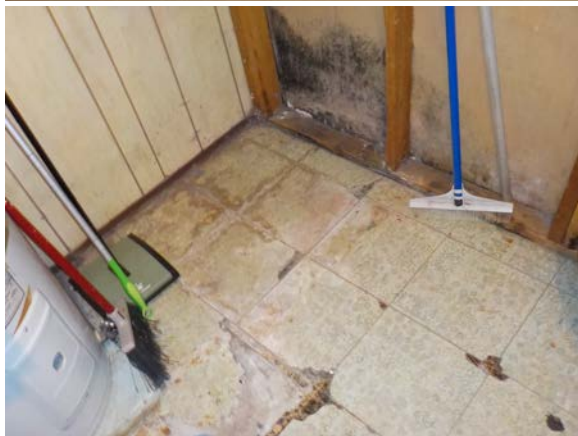
fungal growth in laundry
